The stall of controlled airliners

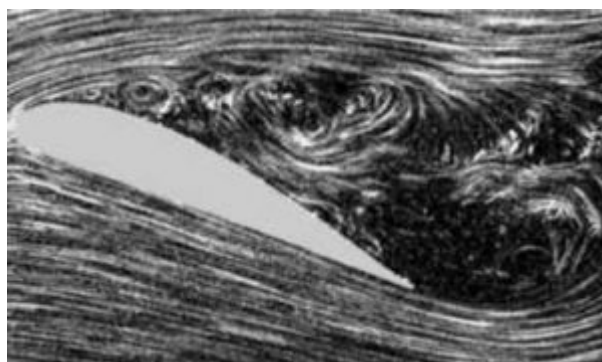
Figure 1. Wind tunnel visualization of the delamination of the boundary layer on the upper surface of a wing with an incidence exceeding a certain threshold [Source: By Jaganath at English Wikipedia]GFDL (<http://www.gnu.org/copyleft/fdl.html>) or CC-BY-SA-3.0 (<http://creativecommons.org/licenses/by-sa/3.0/>), via Wikimedia Commons]

Most air disasters that have remained in memory, such as Air France Flight 447 from Rio to Paris in June 2009, involve a **stall**. This term refers to a loss of altitude due to a decrease in lift, which is caused by the disbonding of the boundary layer present along the upper surface of the wing, as shown in Figure 1. The aircraft, whose weight has not decreased, then engages in a fall that can only stop if the pilot or autopilot system can correct this loss of lift.

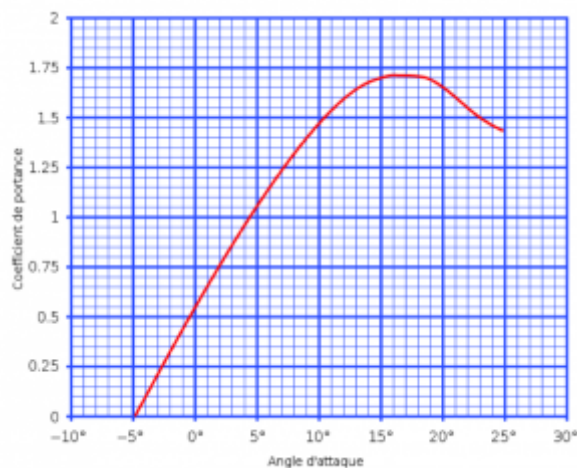
Figure 2. Example of variation of the lift of a wing as a function of its incidence (or angle of attack). The lift of the tested wing varies almost linearly between -5° and $+10^\circ$, then reaches a maximum around 16° before decreasing

Let's see what it's all about first. Since lift is the result of pressure forces on the wing contour, for it to be positive, it is necessary that the air velocity on the upper surface (above the wing) is greater - the pressure lower - than that on the lower surface (below the wing). However, the opposite happens in the event of a well marked separation, since the vortex clearly visible in Figure 1 brings air back to the immediate vicinity of the wall and thus reduces the relative velocity between the wing and the surrounding fluid. This phenomenon, which is not violent but progressive, is linked both to a slowdown of the aircraft, which is already sufficient to explain a reduction in lift, and to an excessively rapid increase in incidence, often controlled by the pilot to compensate for the decrease in speed. The critical value of the incidence leading to the stall depends on the speed and shape of the wing. In general, it is between 5° and 20° ; it is close to 16° in the particular case of Figure 2. Moreover, since this stall is related to the disbonding of the boundary layer, as soon as it appears, the eddies present in the area of the wall that is lifted off generate fairly large pressure fluctuations that shake the aircraft and thus warn the pilot.
